Oil Impregnated Paper Condenser Transformer Bushing Damage Accident Analysis

Tong Wu, Lixia Shang, Huijie Cao, Jiaying Wang, Xiaolei Yang, Xinming Chuai, Haoming Zhao, Zhao Zhang, Shuyi Tao, Huiyan Cao

Marketing Dept. Metrology Division Liaoning Province Electric Power Co., Ltd, China

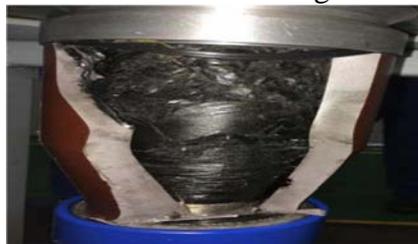
On December 21st, 2017, the main transformer was checked at the site for hanging cores. After the core was removed, cracks were found in the lower porcelain sleeve of the bushing. Up and down through cracks occurred along the circumference of 1/3 of the area. The damaged part of the porcelain sleeve falls off, and the exposed surface of the corresponding insulating core had a large area of significant carbon black discharge traces. There was a large amount of ice in the upper cavity of the sleeve uniform pressure ball. As shown in Figure 1.

Fig.1. Damage of the lower porcelain sleeve of the bushing

According to the observation, there was icing phenomenon on the upper part of the uniform pressure ball in the bushing oil, which was caused by the water flowing out of the bushing after the damage of the lower porcelain sleeve. The direct cause of bushing discharge and cracking of lower porcelain sleeve was water inflow inside the bushing. Therefore, it was the key point to analyze whether there was a sealing problem in the bushing. In addition, no apparent leakage of oil was

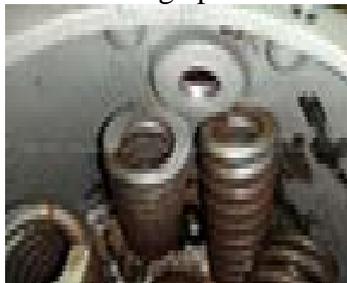
According to the analysis conclusions in the appearance inspection, there was no leakage of water in the parts below the oil surface in normal condition of the bushing. Therefore, all sealing points in the oil surface above were further examined and analyzed. There are 3 sealing positions involved in the parts above the oil surface. (1) Between the bushing connection seat and the oil collecting box cover. (2) Between the oil collecting box cover and oil collecting box. (3) The drain plug of the head of the bushing. The inspection had shown that the fasteners between the bushing connection seat and the oil collecting box cover, the oil collecting box cover and the oil collecting box were not loose, and the sealing gaskets were intact. However, it had been found that the drain plug of the head of the bushing was not effective in fastening (the plug should be loosened by hand), the sealing performance was not enough, and there were traces of water seepage in the interior of the bushing, so as to judge it should be the leakage point of the bushing. As shown in Figure 2.

Fig. 2.The bushing failure location

Through the analysis of bushing operation and core inspection, it is believed that the root cause of the failure here is that the bleeder plug is not tightened during the operation of the bushing bleed plug, and its sealing performance is destroyed. When the ambient temperature of the site is low, the transformer oil in the bushing is in a state of micro-negative pressure due to the thermal expansion and contraction. The water vapor and rain and snow, which are present near the venting plug of the bushing head, are sucked into the bushing. The tube flows along the inner wall of the porcelain sleeve to the tail of the sleeve.

Due to the short insulation part in the bushing with short lower part oil, in the case of water accumulation in the tail of the bushing, the water content in the oil is increased, the insulation performance is lowered, and the bushing is discharged along the surface of the capacitor core under the operating voltage to generate acetylene, resulting in acetylene. The porcelain sleeve is broken.
