Analysis on Internal Cavity Invasion Moisture of 220kV Oxide Arrester

Abstract: In view of a flashover discharge accident, it is caused by internal cavity invasion moisture of a metal oxide arrester, various reasons are discussed for moisture ingress of metal oxide arrester through the construction and assembly process of the metal oxide arrester. The test methods for detecting internal cavity invasion moisture of metal oxide arrester are enumerated. Testers are warned, metal oxide arresters with suspected internal invasion moisture or family defects should be shortened and the test data should be comprehensively analyzed and judged to prevent accidents.

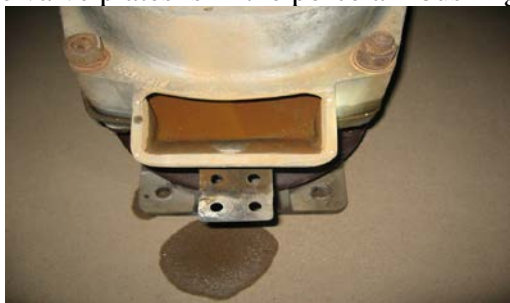
In order to find out the cause of the accident, the appearance of the arrester was first inspected, and it was found that there was water in the flange of the three-phase arrester porcelain bushing, and the water was yellow-brown, so it was judged to contain a lot of rust. Failure phase arrester flange inner fixed steel ring and bolt corrosion is serious, explosion - proof film damage. It is shown in Fig.1. Figure 2 shows the removal of the bottom flange is no.207480T and the removal of the metal oxide valve plates is in the porcelain bushing. The damaged valve plates are scattered.

Fig. 1 Water accumulation at the lower flange

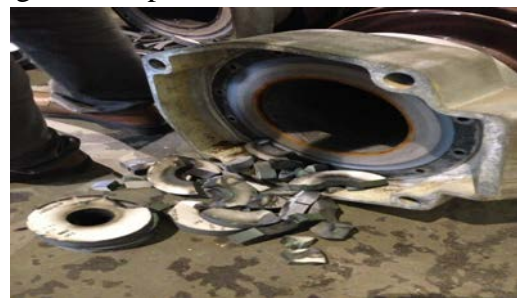
Fig. 2 Scattered valve plates

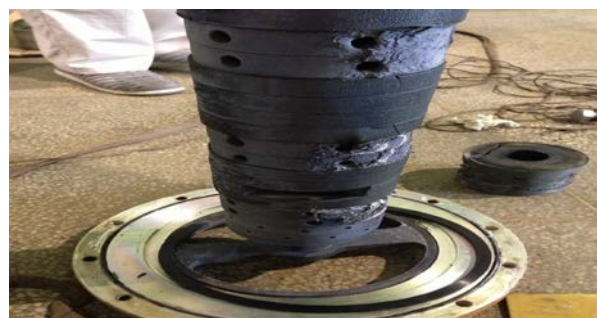
In order to further ascertain the cause of the accident, the replacement of the three-phase arrester was disassembled for inspection. For example, the lower section 207480T arrester is shown to illustrate the internal situation. After removing the bottom flange, the metal oxide disc inside the arrester is removed. Some of the valve plates have been damaged after failure, and the aluminum gasket with round holes between the valve plates has melted under the action of high temperature. It is shown in Figure 3.

Fig. 3 Flashover of valve disc

Therefore, the causes of this accident should be as follows: the low business level of the accident

personnel, they don't know that the small hole filled with nitrogen should be tightly sealed during operation. The long term invasion of moisture will result in serious dampness in the inner cavity, and the internal flashover discharge accident is caused eventually.
