# Optimization Design of Treating Slope Dangerous Rock Mass in Penglai Pavilion

**Abstract.** Slope dangerous rock mass is a common geological hazard in mountain. This paper take the dangerous rock mass of Penglai Pavilion slope as an example that puts forward the design concept of cleaning up dangerous rock mass on the principle of "first easy, difficult afterwards, first on and below, first pry, then top, first push, then push". We put forward the protective measures using SNS active protective net in view of the dangerous rock mass on the slope of Penglai Pavilion. In addition, we also put forward a water cut wall which is made of reinforced concrete structure and arranged three plain concrete structures on the slope. At the same time, we also used to slope masonry retaining wall do to do comprehensive governance. The design has been successfully carried out in Penglai Pavilion and has reference and reference for similar projects.

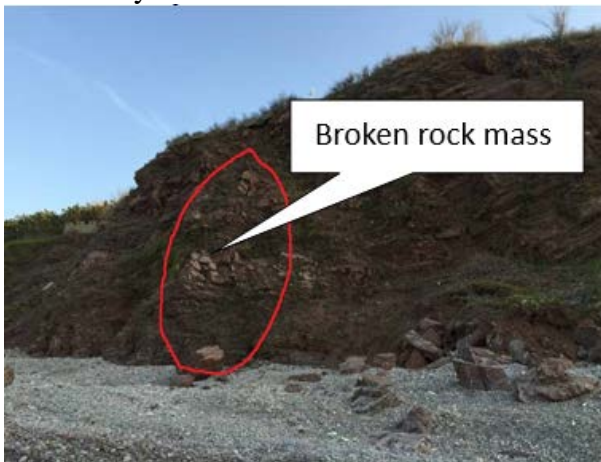
The east of Penglai Pavilion rises from the northwest gate, from the west to the ice and snow world. As show in Fig. 3, the rock slope is exposed between the northwest gate of Penglai Pavilion and cableway South Station. Rock affected by wind, sea, rock surface weathering serious geological disasters, and has appeared the phenomenon of collapse and rockfall. As show in Fig. 4, the old

Fig.3 Slope rock

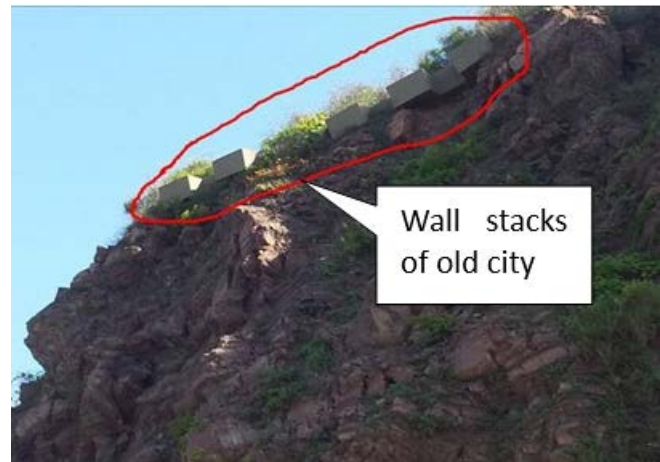
wall piled walls on the top of the slope have been inclined obviously and may collapse at any time. The height of the slope is relatively large, and it is closer to the coast, which poses a serious threat to the safety of tourists at the seaside.

Fig.4 Wall stacks of old city

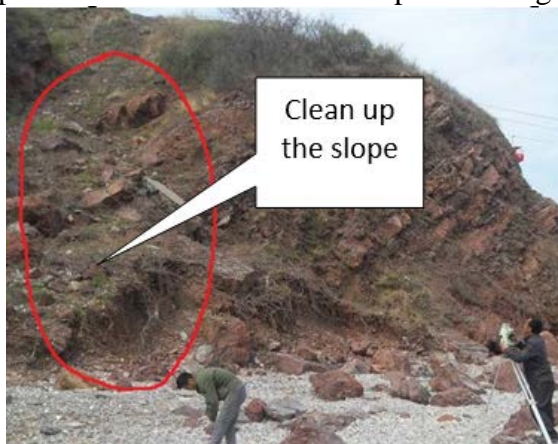
According to the site reconnaissance, there are pumice and dangerous rock in the regional rock slope, which needs to be cleaned up. Clean up the dangerous stone should follow this principle which is "first easy, difficult afterwards, first on and below, first pry, then top, first push, then push". Clear slope staff should ensure that the level of contours at the same time down, not up and down cross operations. The location of the specific dangerous rock body see Figure 5 and Figure 6.

Fig.5 Cleaning area of Slope rock

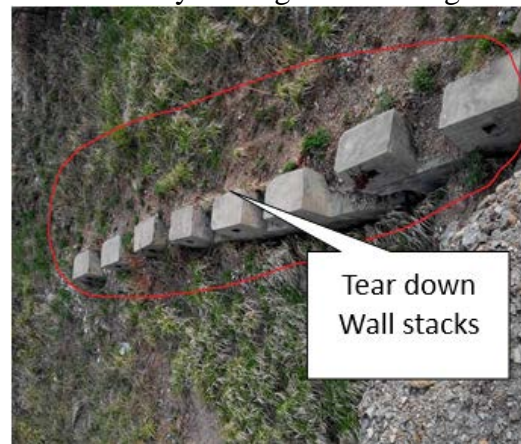
Fig.6 Tear down Wall stacks

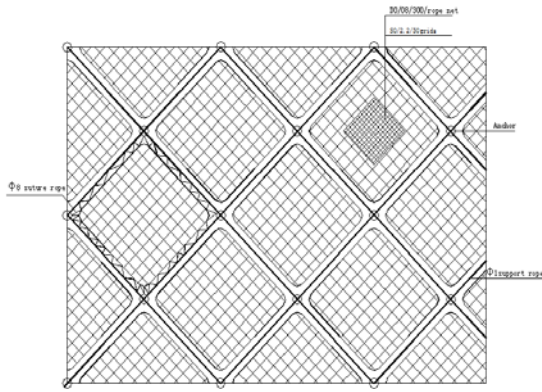
Taking into account the impact of the ecological environment on the scenic spots after construction, this design intends to adopt SNS active protective network protection measures. The active protection network is mainly used for the rock slope of the North West gate of Penglaige and the rock slope on the west side of the mountain and the north side of the South Station of ropeway. Rock slope in the rock mass after the completion of the construction of cleaning, before the active protection network construction. Anchor hole diameter is 60mm, the length of the anchor cable is 3.0m, vertical and horizontal spacing was 2.0m, the plum blossoms along the slope surface, and the angle between the horizontal plane and the horizontal plane is 15 degrees.

Fig.7 Vertical view of SNS protective net      Fig.8 Profile-paper of SNS flexible steel

(2) This design intends to adopt SNS active protective network protection measures. The active protection network is mainly used for the rock slope of the north west gate of Penglaige and the rock slope on the west side of the mountain and the north side of the South Station of ropeway.

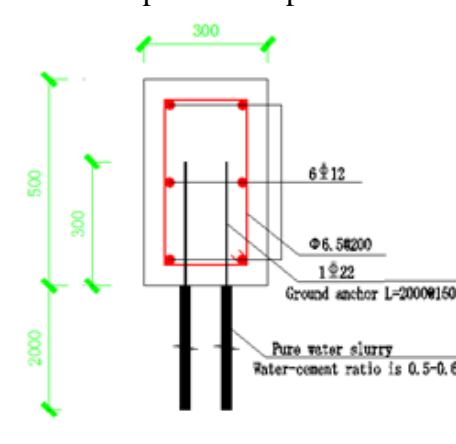
No measures of drainage at the slope of the slope between the northwest gate and the west side of Penglai Pavilion. The top of the slope is directly diffused to the slope, and there is a serious erosion phenomenon on the slope slope. Therefore, the wall is cut at the top of the slope to reduce the impact of rain on the erosion of the slope. The cut wall is made of reinforced concrete structure. The cutoff wall from the top edge of the slope 1.5m, wall height of 0.5m, width 0.3m, the wall set up two rows of anchor, drilling diameter of 60mm, anchor length of 2.0m, anchor into the wall length of not less than 0.3m. The anchorage distance of the anchor anchor along the slope is 1.5m, the rod material is 1C22 steel bar, the pure water slurry is filled in the hole, and the water-cement ratio is between 0.5 and 0.6. The main reinforcement in the wall is 6 C 12 reinforced, the stirrup is made of Φ6.5 steel, the stirrup spacing is 200mm, the thickness of the protective layer is 50mm. The cutoff wall concrete strength grade is C25. The cutoff wall shall be constructed according to the site topography and the water outlet shall be reserved on the slope drainage site to avoid the phenomenon of water accumulation at the top of the slope.

Fig.9 The detail drawing of cutoff wall

(3) The wall is cut at the top of the slope to reduce the impact of rain on the erosion of the slope. The cut wall is made of reinforced concrete structure. The cutoff wall from the top edge of the slope is 1.5m, wall height is 0.5m, width is 0.3m.

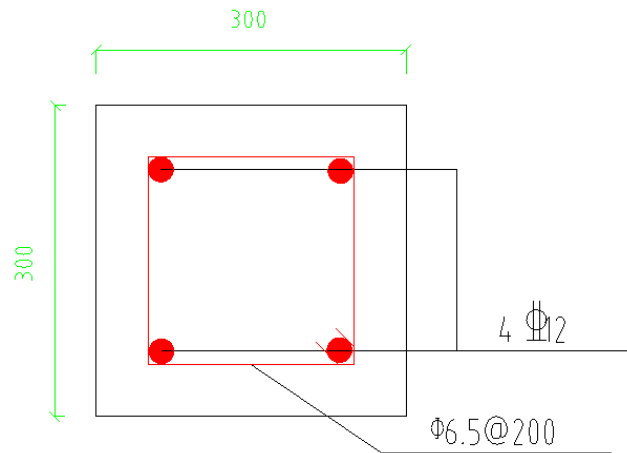
There are three drains on the slope, and the ditch is located on the slope. The ditch is constructed of concrete in the form of concrete, and the concrete strength grade is C25. The surface of the ditch is laid with cement mortar. Cement mortar specifications are M10. Mortar surface laying pebbles, pebbles diameter 3-5cm, pebbles should be as far as possible local materials, so that coordination with the surrounding environment. The ditch is 1.5m wide, the step height is 15cm and the step width is 35cm. Drainage at the bottom of the laying of concrete cushion, cushion thickness of not less than 10cm, the thickness of the actual situation should accord to the scene to adjust. The cushion concrete strength grade is C25. The reinforced concrete structure is adopted on both sides of the steps, and the channel wall specification is 300\*300mm, and the concrete strength grade is C25. The stirrup is made up of 6.5 steel bars, the spacing between stirrups is 200mm, and the thickness of reinforcement protection layer is 50mm.

Fig.10 Waterfall gully wall reinforcement.

(4) There are three drains on the slope, and the ditch is located on the slope. The ditch is constructed of concrete in the form of concrete, and the concrete strength grade is C25.

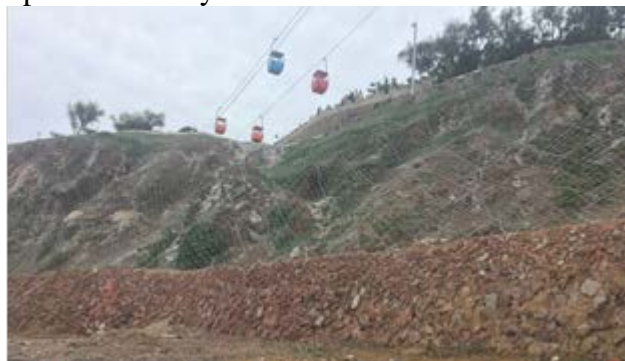
Through the collapse and rockfall in the area, the old city wall pile on the top of the slope is removed and slope is cut. Through doing the slope protection, setting the wall, doing the slope drainage, slope foot retaining wall, greening and other measures in this area to eliminate the security risks. It protects the personal safety of tourists.

Fig.11 Slope treatment
