Research on Fault Analysis Technology of Hydraulic Generator Set

Keywords: bearing temperature measuring resistance; fault causes; improvement measures

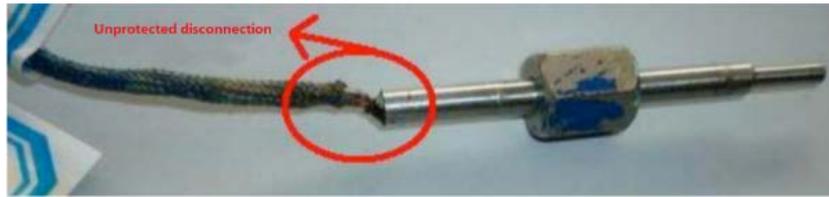
As the temperature measuring element installed on the bearing bush has been subjected to continuous vibration during operation, there is no spring in the fixed part to cushion the impact of vibration on the element.

Figure 1. The root of the sensor is disconnected.

The oil resistance, corrosion resistance and heat resistance of the temperature wire are relatively poor; in the oil-immersed environment for a long time, it is easy to harden, brittle, skin cracking and other phenomena, shortening its service life; long-term vibration will cause the wire to be disconnected at the root of the sensor (see figure 1, figure 2). After on-site inspection, it is found that the fault of root broken line accounts for almost 50% of the total number of temperature measurement resistance faults.

A special spring is installed in the fixed part of the element, to cushion the influence of the vibration of the unit on the temperature measuring element; to select the outer insulation material with excellent oil resistance, corrosion resistance and heat resistance for the temperature measurement lead to prolong the service life of the wire; use the temperature measuring wire with dense mesh shield to reduce the interference of strong magnetic field to the temperature measuring element.

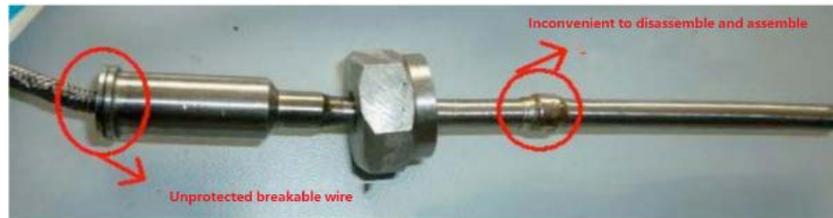
Figure 2. The root of the sensor is disconnected.

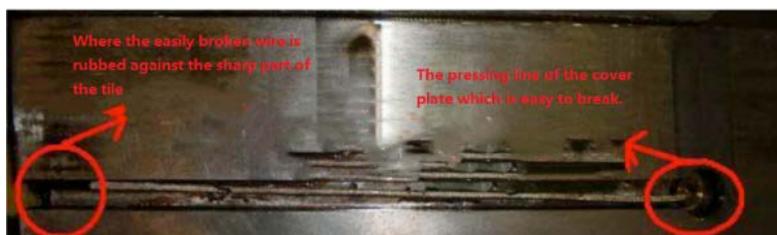
The wire is fixed and tied with plastic bandage, which is easy to hurt the outer skin of the wire. The fixed wire card in the oil tank is made of thin iron sheet, and its edge is more sharp. If the outer skin of the wire is not wrapped in the protective layer, it is easy to be damaged by the sharp part and retain the hidden danger. Some wiring is not secure in the oil tank, and the temperature measurement line is broken at the joint caused by oil flow and surge during the operation of the unit, as shown in figure 3.

Figure 3. The temperature measurement lead is worn out.

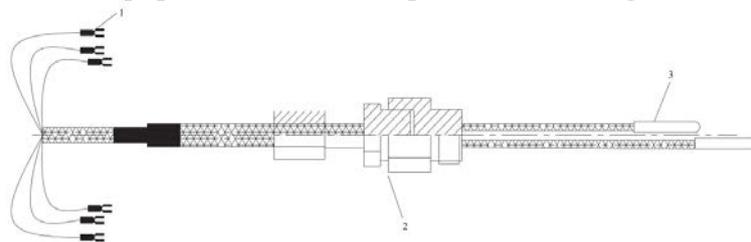
During the normal operation of the unit, once the temperature measuring element is damaged, it is very difficult to replace. In order to improve the operation reliability, double-branch temperature measuring resistors should be used in important parts such as thrust and guide bearings as far as possible. That is, two thermal resistors with the same indexing number and the same precision are arranged in the same sheath to measure the temperature at the same point. The lead wire of the temperature measuring element should use a six-wire system to eliminate the influence of the imbalance of lead resistance on the measurement results. The use of double-branch temperature measuring resistance can lead to two measuring points in the same position, and the leads of the two measuring points are led to the terminal box on the outer wall of the oil basin. Under normal circumstances, one is in operation and the other is used as a backup. When the component fails, the external cable can only be connected to the spare component at the terminal box, which reduces the hidden danger that the equipment can not be replaced after a single resistance is damaged.

Figure 4. Schematic diagram of double-branch temperature measurement resistance structure
