Tensile Property Evaluation of Stepped Scarf Joint Repair for Wind Turbine Trailing-Edge Laminate

Keywords: Blade trailing-edge; stepped scarf joint repair; time-domain analysis; experimental test of stepped scarf joint repair;

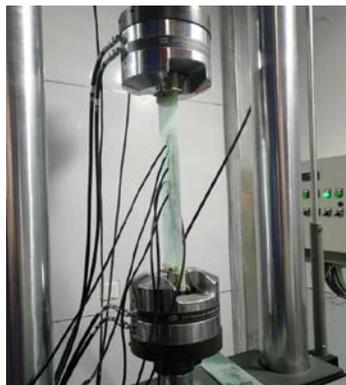
Figure 8 Experimental setup

Fig.8 shows the experimental setup of tensile test, test speed was 2mm/min. The dynamic strain gauges were used to measure the strain changes at key points of the samples. The test points were distributed in joint areas, non-repair areas and repair ply areas.
