Tensile Property Evaluation of Stepped Scarf Joint Repair for Wind Turbine Trailing-Edge Laminate

Keywords: Blade trailing-edge; stepped scarf joint repair; time-domain analysis; experimental test of stepped scarf joint repair;

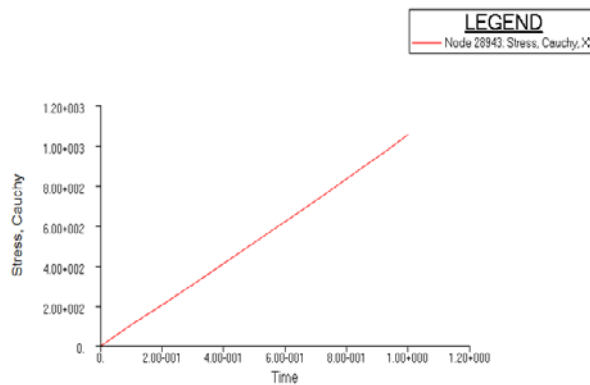
The midpoint of the outermost layer of the whole model is extracted as a characteristic point. The stress-strain curve of this characteristic point is linearly distributed, as shown in Fig5, because of the linearity of material and no periodic variation of displacement load.

Figure 5 Stress-strain curve of the characteristic point

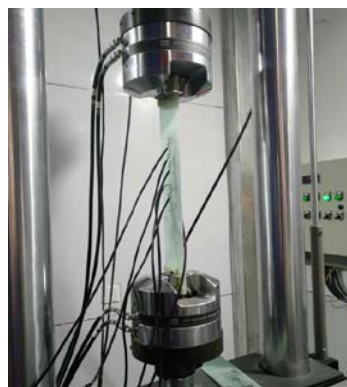
Figure 8 Experimental setup

Fig.8 shows the experimental setup of tensile test, test speed was 2mm/min. The dynamic strain gauges were used to measure the strain changes at key points of the samples. The test points were distributed in joint areas, non-repair areas and repair ply areas.
