Research Progress of Polymer-modified Repair Materials for Concrete Pavement

Keywords: Polymer-modified concrete, Pavement repair materials, Research progress

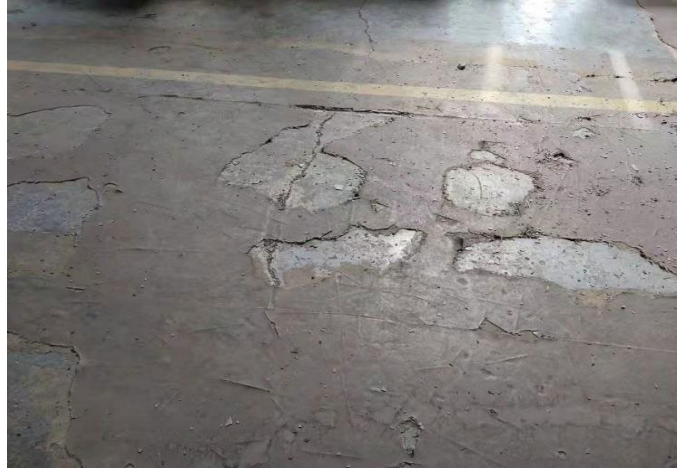
Figure 1 Secondary damage of concrete pavement after repair

After large-scale infrastructure construction, China's highway mileage has basically met the needs of economic. The total length of highway mileages has reached 5.2807 million kilometers by the end of 2021. The length of cement concrete pavement is about 3.1 million kilometers [1]. Due to the rapid increase in traffic flow and the increasing demand for public transportation, the damage of cement concrete pavement is serious. In many regions of China, the highway's partial repairing period has been shortened from the rated 5-year to 3-5 years. Comprehensive-repairing period has been shortened from 10 years to 5-8 years. During the 13th Five-Year Plan period, the engineering's amounts about highway partial-repairing and comprehensive-repairing will increase rapidly. During the 14th Five-Year Plan period, the amounts will reach the peak [2]. It is necessary to repair the damaging road surface. Not only can it improve traffic safety index, but it can also extend road life. However, some repairs' lifespan is very short, resulting in secondary damage. Repeated repairs result in national construction resources waste. The secondary damage of the repairable concrete pavement is shown in Figure 1.
